2007-2008 Solstice/Sky 2.0 Turbo ECM Removal

Engine Control Module Replacement

TECHNICAL

- Engine Will Not Crank After A Battery Disconnect, Dead Battery Condition Or After A Reprogramming Event, Theft Deterrent Light Illuminated, DTC B3060 Stored, One Key Starts Vehicle But Second One Does Not (Reprogram Keys Into Theft Deterrent Module).

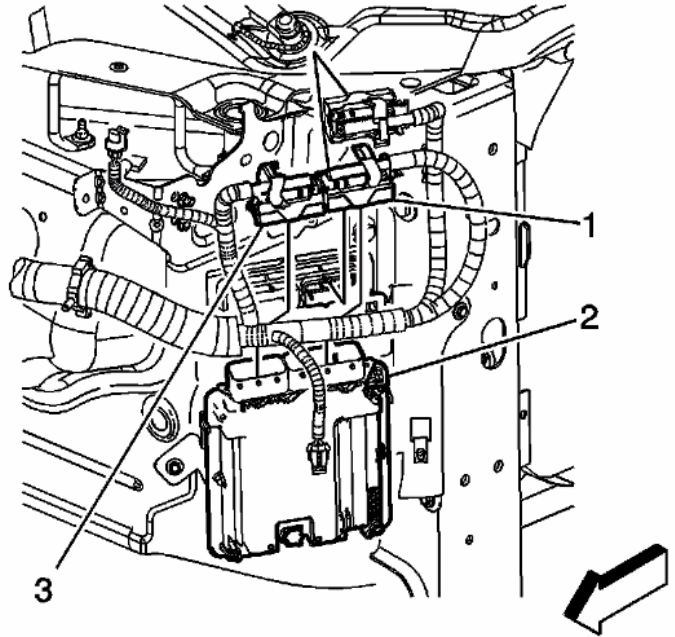
Disconnect the engine harness electrical connectors (1, 3) from engine control module (ECM).

Release the upper and lower retaining tabs (1, and 2) using a small screwdriver or other suitable tool.

Remove the ECM by lifting upward after releasing the tab.
